## Failure investigation into the boiler tubes of power plant

Badaruddin Soomro \*, Muhammad Irfan, Bilal Waseem, Sumaira Nosheen, Abdul Karim Aziz and Hamza Butt

International Journal of Science and Research Archive, 2021, 02(02), 028–036

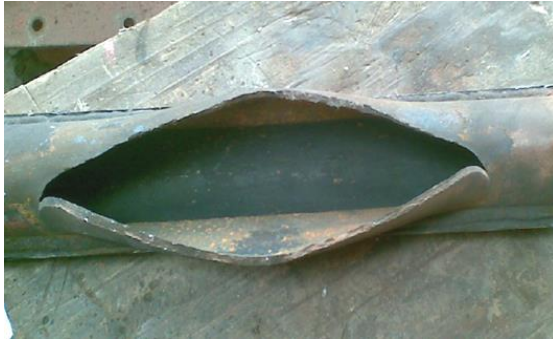
A boiler tube, made of SA-210 Grade A-1 steel (ASTM A 210) [3], ruptured within one year of its service period (as shown in Figure 1). The header tube was found to be blocked (clogged) due to scale formation (as shown in Figure 2). A study was conducted to determine the cause of rupture.

**Figure 1** Ruptured boiler tube

On the basis of above mentioned results and discussion, it was concluded that, the brittle fracture (rupture) of tubes was occurred due to over-heating caused the formation of thermally insulating thick iron oxide scale on the inner surface of the boiler tube. This may be prevented by proper maintenance of tubes.

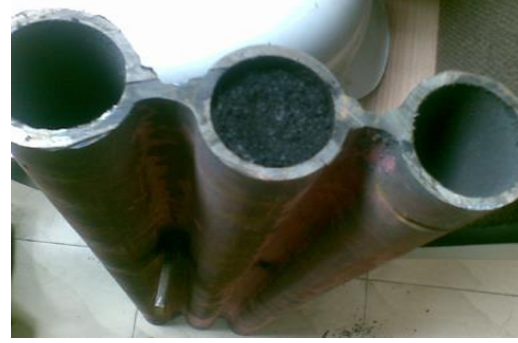
**Figure 2** Blocked header tube

The scale and residue found in the clogged tube was collected from inside of the tube. The chemical analysis of scale was performed by Wet analysis technique as per ASTM D 2331. The result shows the composition of iron oxide (as shown in Table 1).

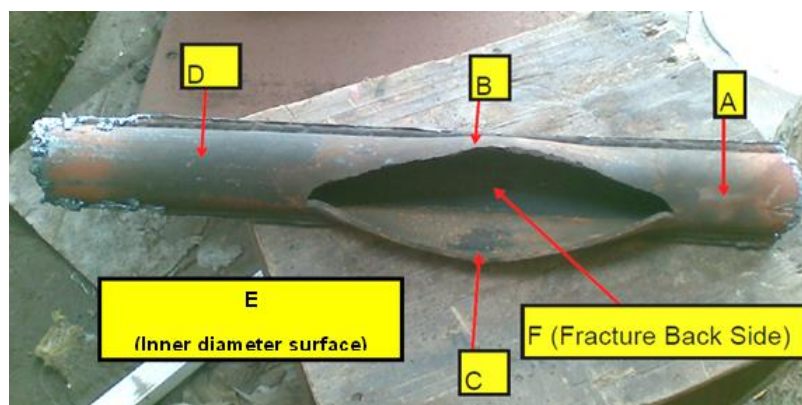
The samples were extracted from the rupture zone as well as from the unaffected zone of boiler tubes for analysis (as shown in Figure 3).

**Figure 3** Locations of extracted samples of the boiler tube

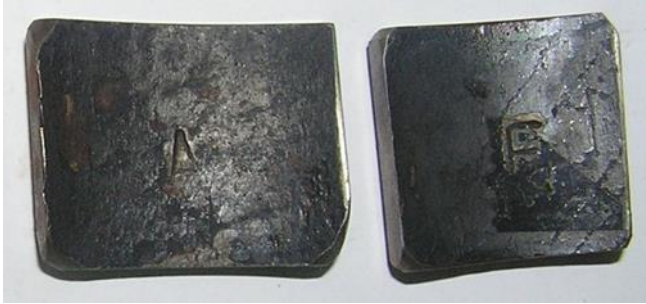
First of all, as received samples of tube were examined visually. A dark layer was observed on the inner surface of sample A & F, which are from the undamaged areas of the boiler tube (as shown in Figure 4). But it was not found on the inner surface of sample B & C, which are from the surrounding areas of the fractured location. However, the corrosion was observed on the inner surface of sample B & C (as shown in Figure 5).

**Figure 4** Oxide layer (scale) on the inner surface of sample A & F

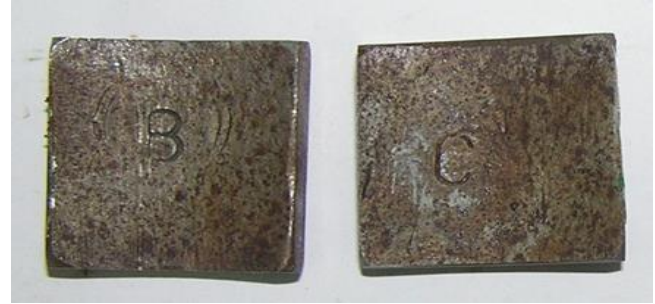
**Figure 5** Corrosion on inner surface of sample B & C

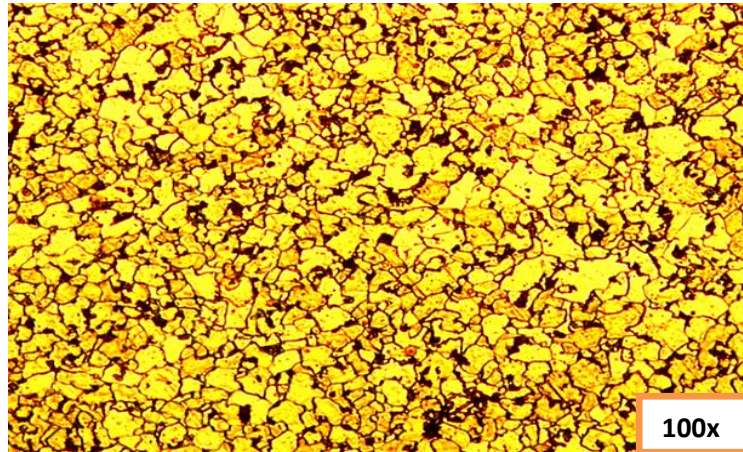
The microstructure of transverse cross-sectional surfaces of samples A, B, C & F appears to be consisted of ferritic matrix with uniform distribution of pearlite (as shown in Figure 6). Whereas; the microstructure of longitudinal cross-sectional surfaces of sample A, B, C & F appears to be consisted of ferritic matrix with banded pearlite (as shown in Figure 7).

**Figure 6** Transverse cross-sectional micrograph showing ferrite & pearlite.

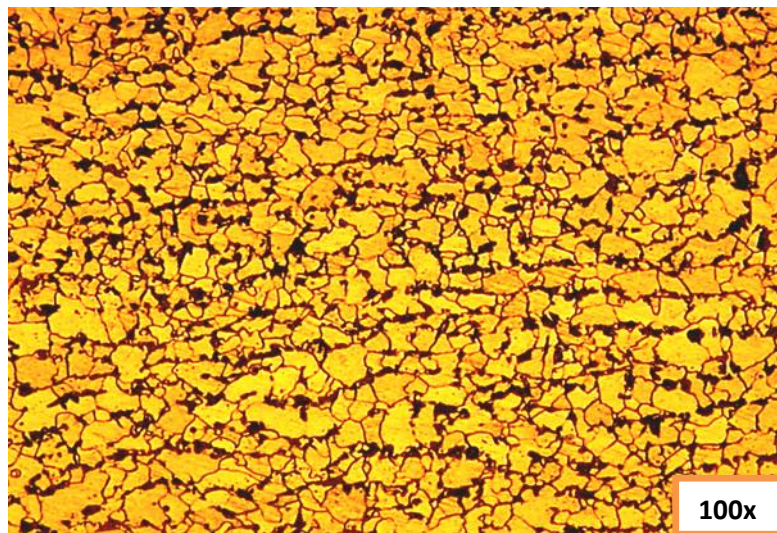
**Figure 7** Longitudinal cross-sectional micrograph showing ferrite & banded pearlite

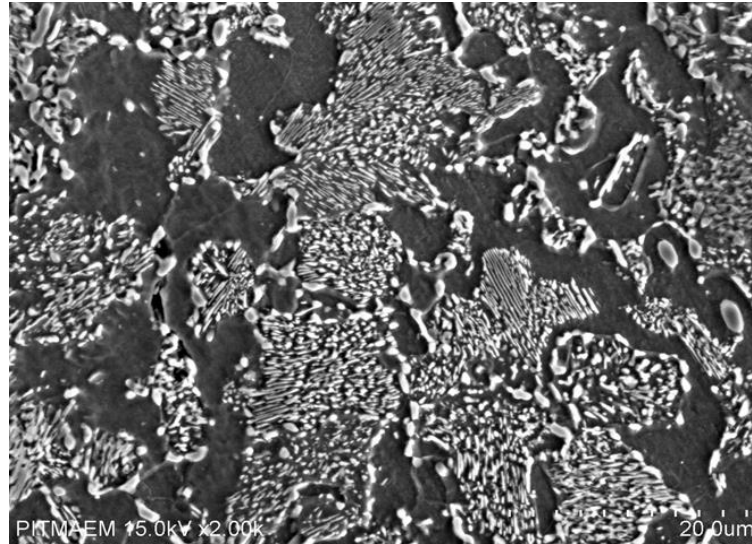
The microstructure of the inner surface near the fractured region of sample E appears to be of ferritic matrix with relatively non-uniform distribution of pearlite (as shown in Figure 8 & 9). As mentioned earlier in Section 2.7, ID surface of boiler tube experienced some grain growth due to over-heating (as shown in Figure 9). It was observed that this non-uniformity in grain size & pearlite distribution might be playing a role in the eventual failure of boiler tube.

**Figure 8** SEM micrograph showing ferrite and lamellar structure of pearlite

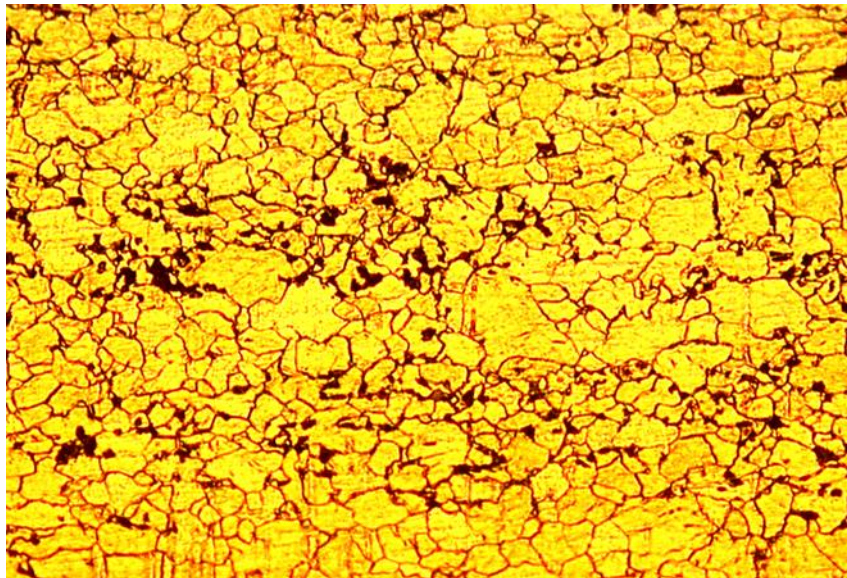
**Figure 9** Cross-sectional micrograph showing grain growth and non-uniform distribution of pearlite

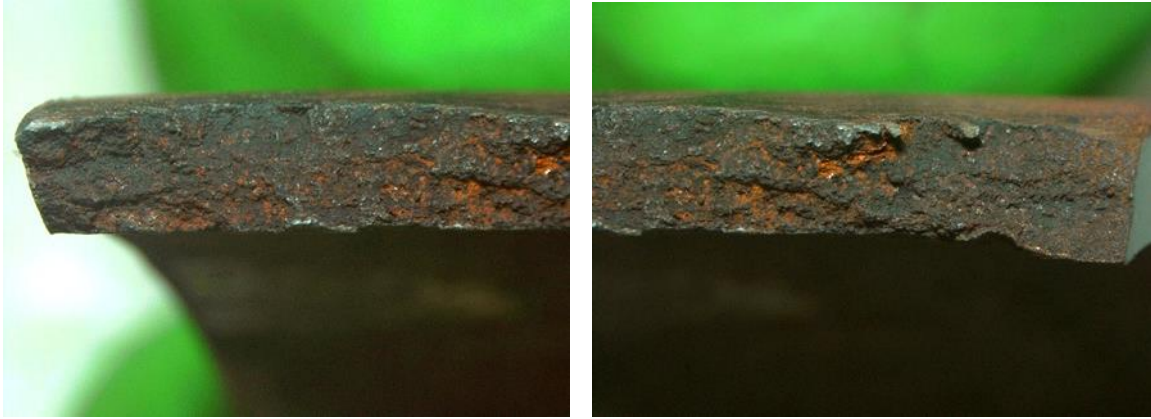
Fractography was performed via Optical Microscopes (Zoom Microscope, SZX7, Olympus, Japan; DM4000M Image Analyzer, Leica, Germany), on the fractured regions of sample B. The fracture surface appears to be of brittle nature with negligible amount of plastic deformation (as shown in Figure 10). The outer diameter surface of sample B reveals cracks as indicated by arrows, which appeared to be formed during fracture (as shown in Figure 11). Transverse cross-section of fractured zone of boiler tube indicated intergranular fracture (as shown in Figure 12).

**Figure 10** Fracture surface of sample B

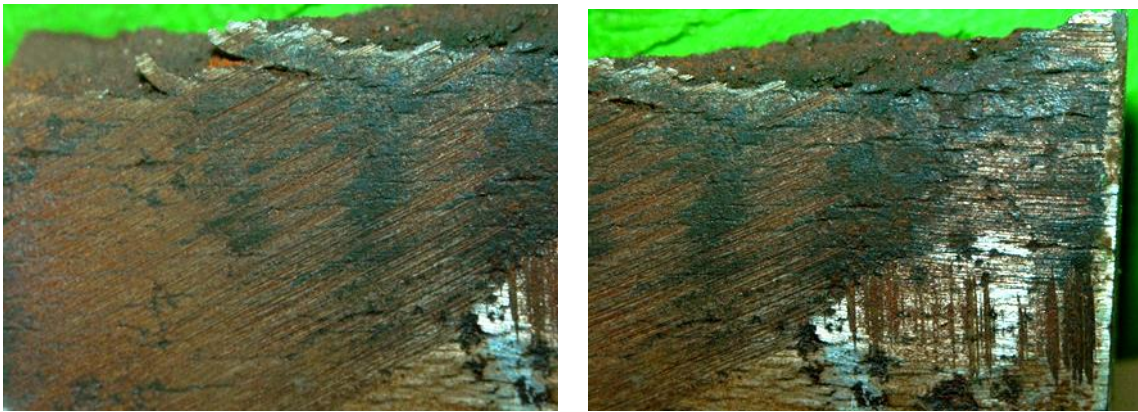
**Figure 11** Top surface of sample B

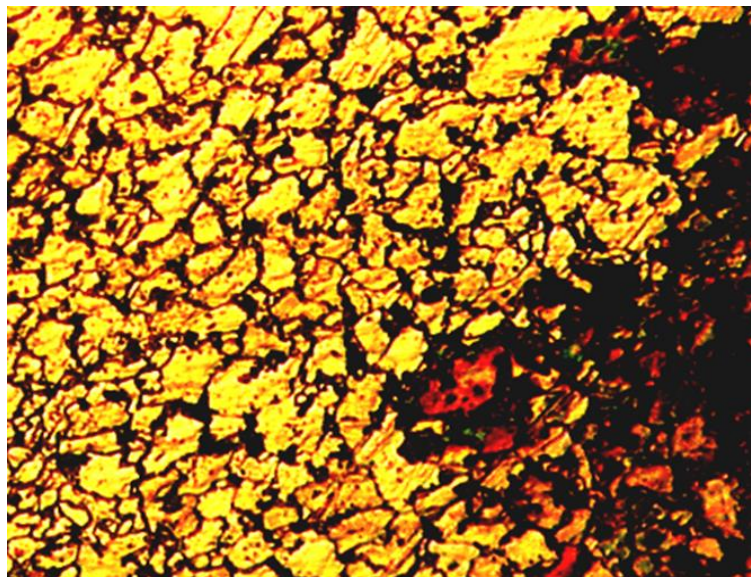
**Figure 12** Transverse cross-sectional micrograph of fractured zone of boiler tube showing intergranular fracture of boiler tube (sample B)
