Analysis of hydrogen embrittlement in zinc electroplating

International Journal of Science and Research Archive, 2023, 09(01), 208–212

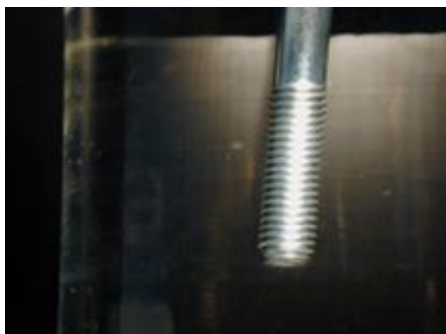
Figure 1 Paraffin test -Grade = 1 OK

- On the heater and place the Beaker (with the oil inside) in the center.
- Check the temperature of the oil to rise until 185°C.
- Stabilize the temperature to maintain it constantly.
- Drop the plated part inside the oil for a maximum time of 3 minutes.
- The presence of effervescence needs to be observed and high or excessive effervescence-producing parts are rejected.

- GE = 1 inexistent effervescence
- GE = 2 low or irrelevant
- GE = 3 medium effervescence
- GE = 4 high effervescence
- GE = 5 excessive effervescences

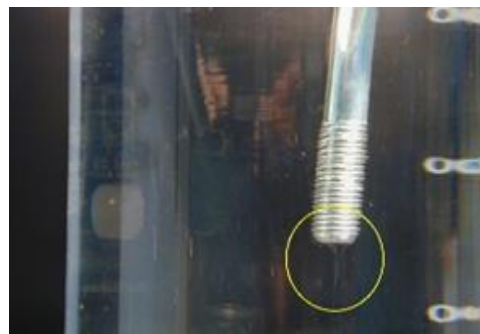
Figure 2 Paraffin test -Grade= 2 OK

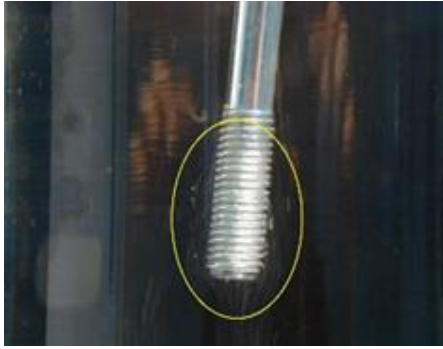
Figure 3 Paraffin test -Grade = 3
SUSPECT
