## The barriers on the walkways' formation for wheelchair users in Wuhan city

International Journal of Science and Research Archive, 2024, 12(02), 2755–2768

This study investigates the barriers affecting the mobility of wheelchair users (WUs) within the walkways network of the city of Wuhan in China. Utilizing an access audit and comparative research approach, the research aimed to identify and evaluate obstructions affecting WUs' navigation. The methodology involved two key components: visual observations and a comparison against Chinese accessibility standards, specifically the Codes for Accessibility Design (GB50763-2012) and the General Code for Barrier-free Construction and Municipal Engineering (GB 55019-2021). A comprehensive evaluation checklist, encompassing structural and physical barriers, access points, pick-up/drop-off areas, area information, and traffic control, was employed to systematically assess the environment. Key findings reveal several critical issues, including uneven pavement surfaces, insufficient curb cuts, and overcrowded sidewalks. These problems significantly impair smooth navigation and increase safety risks. Uneven sidewalks often cracked or poorly

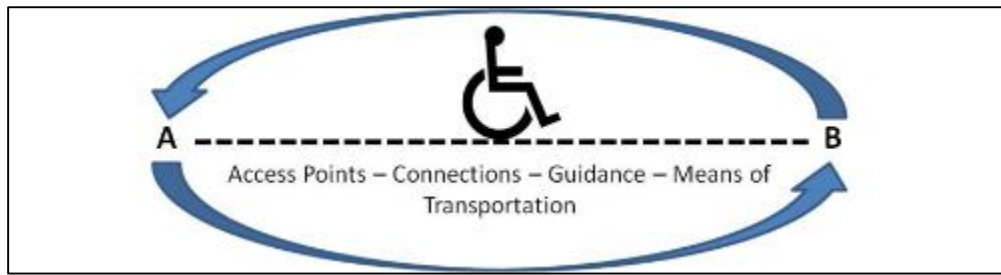
**Figure 1** The Route Environment for wheelchair users on the Walkways Network

The urban walkways environment has been designed to facilitate pedestrian movement, thus there exists a critical but often overlooked concern of the barriers that impede the mobility of wheelchair users (WUs). The way people navigate through unfamiliar environments offers insights into the challenges faced by individuals reliant on mobility aids. For WUs, accessibility is not merely a matter of convenience but a fundamental aspect of daily life, shaping their ability to independently navigate and participate in their communities. Despite regulations and standards aimed at ensuring inclusivity, recent audits have unveiled pervasive issues along sidewalks, leisure paths, and general community walkways. These audits highlight numerous obstructions which ranging from inadequate access points to surface conditions that significantly prevent the seamless movement of wheelchair users. The intersection between pedestrian pathways and other modes of transportation further complicates matters, often exacerbating accessibility issues. As cities strive to harmonize the needs of diverse pedestrian groups, the barriers identified in Wuhan city, underscore the ongoing imperative for meticulous design, maintenance, and regulatory adherence in ensuring that public spaces are truly accessible to all.

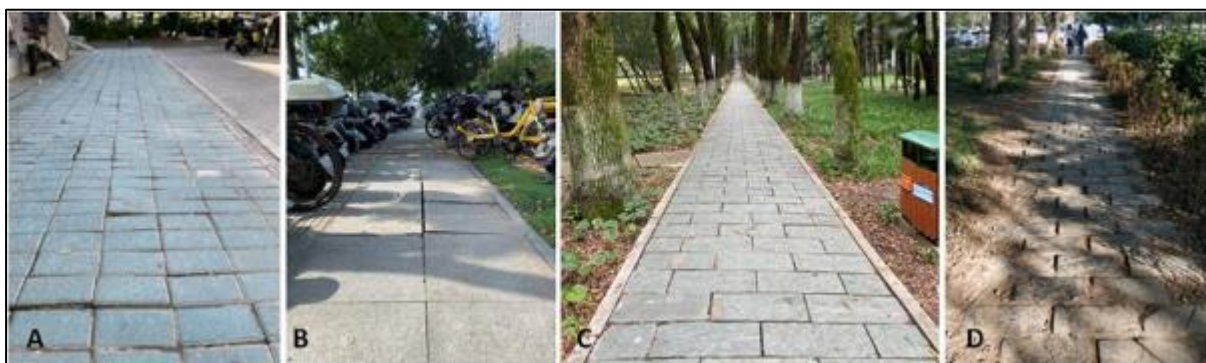
**Figure 2** Walkways surface condition

In Figure 2A, there is a surface deformation, and in Figure 2B, there is an abruptness and movement of paved tiles of walkways. Figure 2C at Huazhong University of Science and Technology (HUST) Youth Park and Figure 2D at East Lake Park show the walkways with rough paved materials and large openings between paved elements.

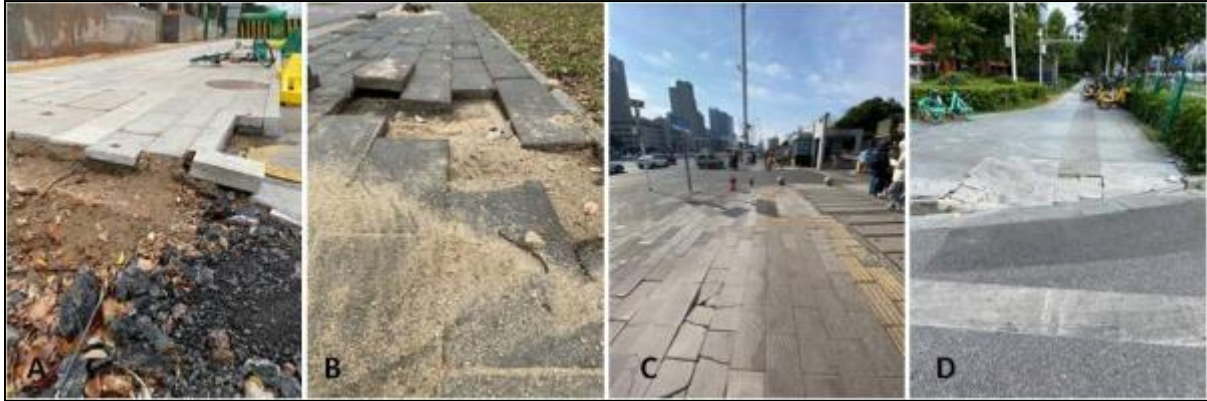
**Figure 3** Walkway paving and damaged surface

Figure 3A shows a typical detail of the sidewalk construction technique, and in 3B, the repair of a deformed walkway at HUST, because of its uncompacted sub-base. In Figure 3C, there are damaged surfaces in front of South Gate 2, and in Figure 3D, a newly made curb ramp was damaged a short time after its construction.

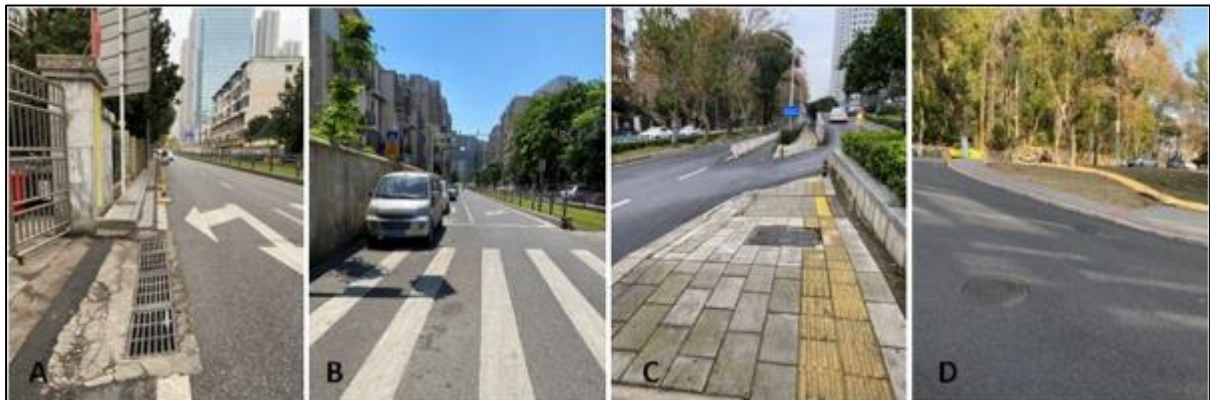
**Figure 4** Walkways formation

In Figure 4A, there is a narrow sidewalk of about 0.7 m in width instead of 1.50 m, including on street furniture such as utility poles. There are also abnormal gutters and drainage grates that obstruct free movement on the route. In Figure 4B, there is an absence of a sidewalk. In Figure 4C, there is a gradient issue on the walkway with steep slopes, and in Figure 4D, there is a morphological issue with steep hills in the walkway environment in HUST, especially in the area by Yujia Mountain.

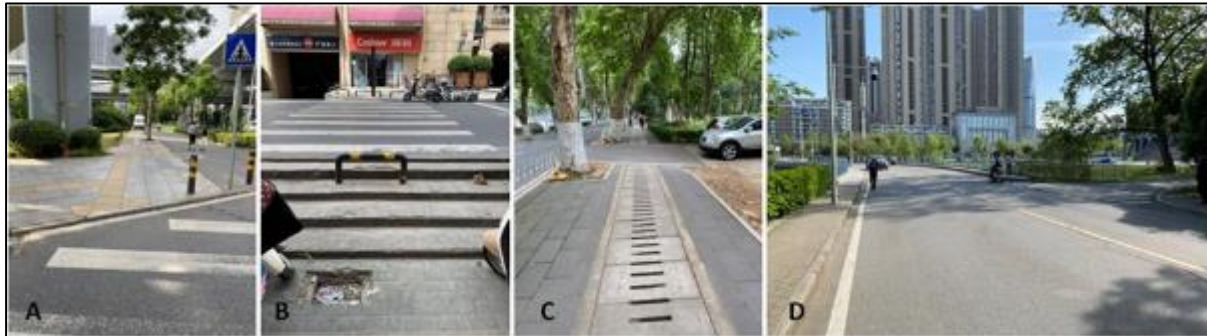
**Figure 5** Obstructions of free movement on walkways environment

The street gutter in Figure 5A creates a difficult access point on the sidewalk for WUs. In picture 5B, stairs, curb edges, and parking rails block access to the sidewalk. The walkways in HUST often have manholes, which are mostly placed in the middle of the way, usually for rainwater drainage (Figure 5C), making the route uncomfortable. Furthermore, on the way to the South Gate 4 of the university (Figure 5D), there are sidewalks without curb cuts and utility poles in the middle of them, making pedestrians walk through the road.

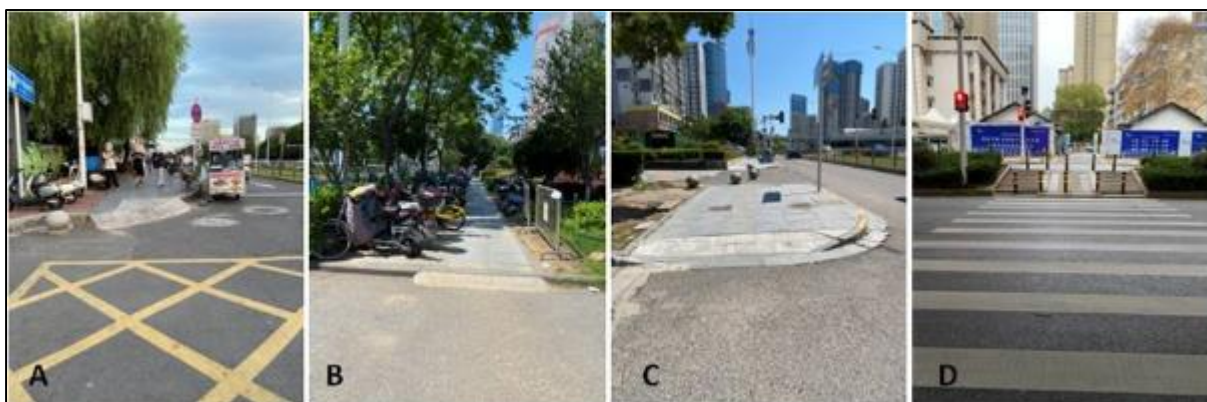
**Figure 6** Curb ramps

In Figure 6A, there is a full-width single-sided curb ramp that had recently undergone partial modification but remains too steep, with 29.2% at the start point and 11.6% in the overall area instead of 5%. For the built-up curb ramp, which afterwards added extra (Figure 6B), the slope is 25.2% instead of 8.3%, as is the maximum slope for general curb ramps. A newly made three-sided curb ramp, Figure 6C, has a slope of 19.3 instead of 8.3%. The curb ramp in Figure 6D, which transits between carriageways within different height levels, has no rest platform, which creates hazards for all pedestrians crossing the street, and the slope is 24.5% instead of 5% for a single-sided curb ramp.

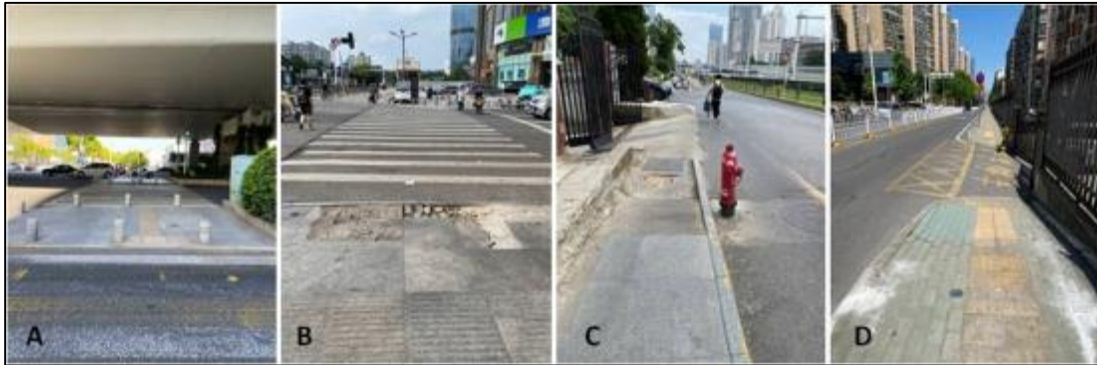
**Figure 7** Crosswalks and general walkways connections

The pedestrian traffic island can be difficult to access by WUs (Figure 7A), as there are curb edges with more than 10 mm, which is the maximum height. The crosswalk in Figure 7B connects with a damaged sidewalk, creating discomfort for any pedestrian, especially for WUs. In Figure 7C, the crosswalk has an uneven surface to a manhole and is interrupted. The sidewalk in Figure 7D has very steep longitudinal and transverse slopes that connect to a private entrance, making the passage difficult for WUs.

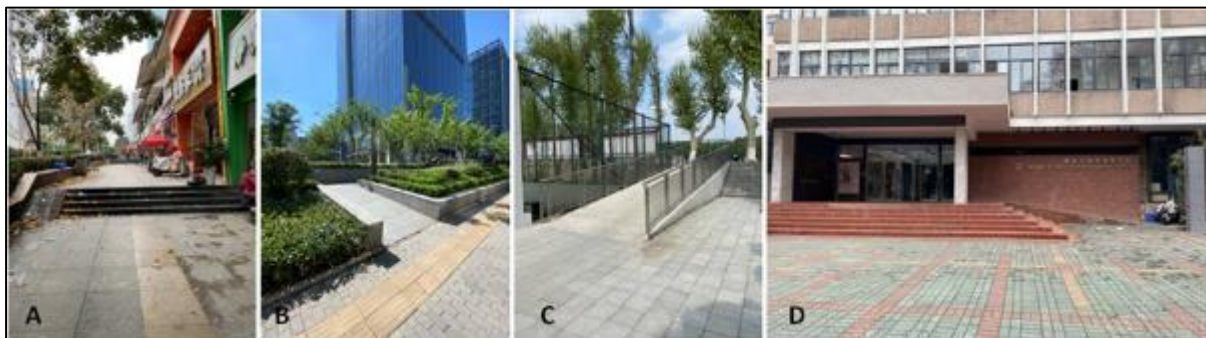
**Figure 8** Buildings' entrances and public space ramps

In Figure 8A, the walkway is directed to shops without access, as there are only stairs and WUs cannot approach them. The ramp that leads to the shopping center (Figure 8B) is 16.2% instead of 10% for ramps up to 0.60 m in height. In Figure 8C, the ramp at the public space of HUST has a run slope of 15.5% instead of 5%, which is for the maximum height up to 1.20 m. The ramp should have a rest platform as the height difference from the start point to the top exceeds 1.20 m. The ramp that assists WUs to access the School of Architecture and Urban Planning at HUST, Figure 8D, has a run slope of 15.5% instead of 5%, which is from height levels between 0.90 and 1.20 m.

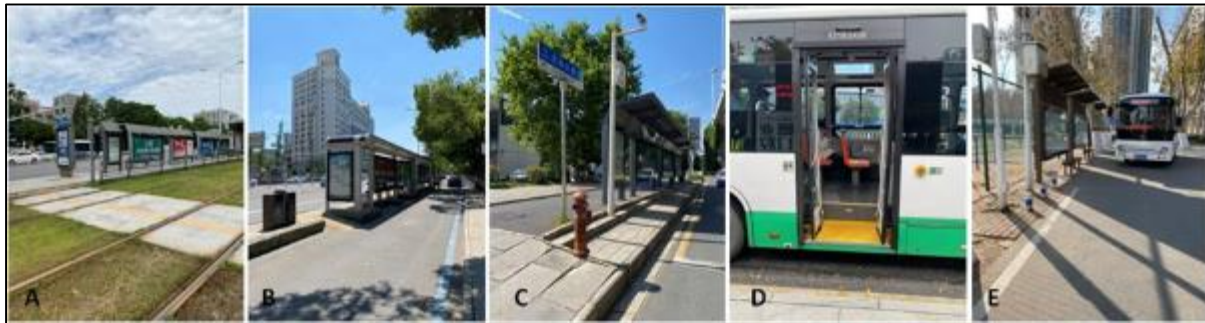
**Figure 9** Bus stops facilities

In Figure 9A, the walkway is directed through the tram line tracks on a raised sidewalk to the bus stop and the tram stop. Figure 9B shows a newly constructed ramp to access the bus stop platform, which is 21% instead of 10%, which should be from heights between 0.30 m and 0.60 m. Furthermore, there is no curb cut on the parallel sidewalk to provide access for WUs through the intermediate road. In Figure 9C, there are steps to prevent from both sides the accessibility of the bus stop and a fire hydrant in the middle of the passage stand on the raised curb edge. In addition, the effective width of the platform is less than 1.50 m, which is the minimum requirement. During the audit, several buses were found not accessible to WUs, as shown in Figure 9D. As Figure 9E shows, the bus stops on the HUST campus also do not meet accessibility standards. The bus stop has no effective platform width and is placed on the roadside. Its location provides many obstacles and hazards to pedestrian flow, and all buses are not accessible to WUs.

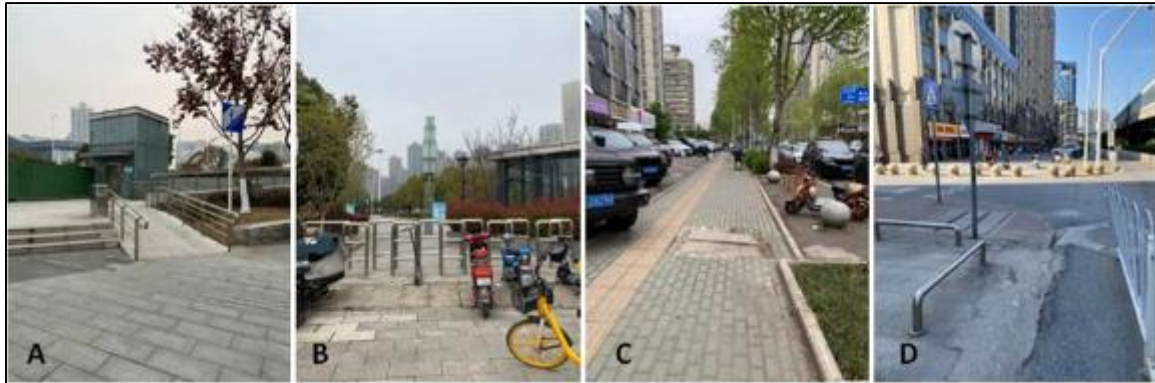
**Figure 10** Metro access (A-B) and side stop for personal transportation (C-D)

In Figure 10A, there is a new ramp to access the metro station which has 11.9% instead of 10%, which is the max slope for height between 0.30 m and 0.60 m. In Figure 10B, there are parking railings that prevent access to WUs in the area where there is public space and the way to the metro station, as there is not enough space to pass by. The roadside access in Figure 10C has curb edges greater than 10 mm, which is the maximum height on accessibility standards, and also the access is prevented by parked vehicles. In Figure 10D, there is no side area for vehicles to stop on the main street to pick up and drop off a passenger.

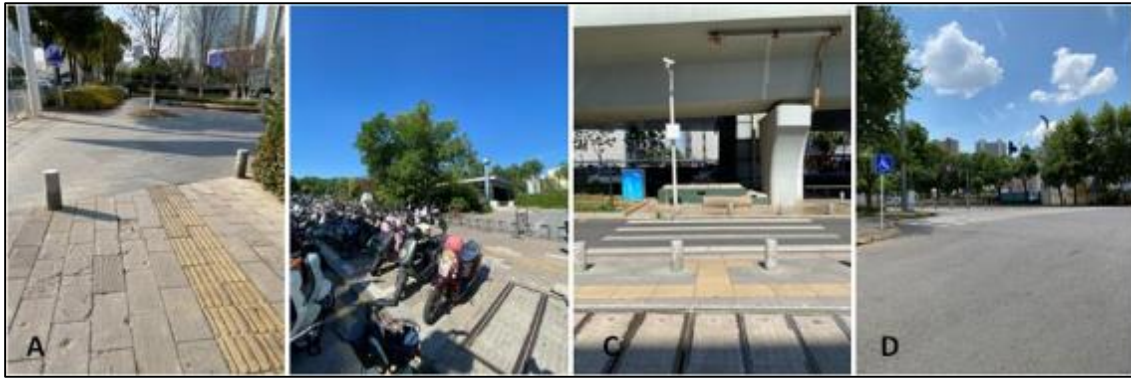
**Figure 11** Information and pedestrian guidance

In Figure 11A, a road sign shows the direction for the underground pedestrian crossing, but there is no information about the access by WUs, as there is an elevator at this crossing. The entrance point of the metro station in Figure 11B is not accessible by WUs, but nearby there is an elevator that provides accessibility, and there is no directional sign to provide information about it. In Figure 11C, it is a pedestrian crossing through a pedestrian traffic island on a main road. The route direction of the pedestrian crossing is not straightway as it should be, because there is a utility structure on the way. There is no information about it, and there isn't a sign with a route to guide the pedestrians. The crosswalk in Figure 11D has a sign about accessibility, but there is no information about the crossing. In this case, there should be a sign for pedestrian crossings, and the sign for accessibility could be additional, as pedestrian crossings should be accessible in general.

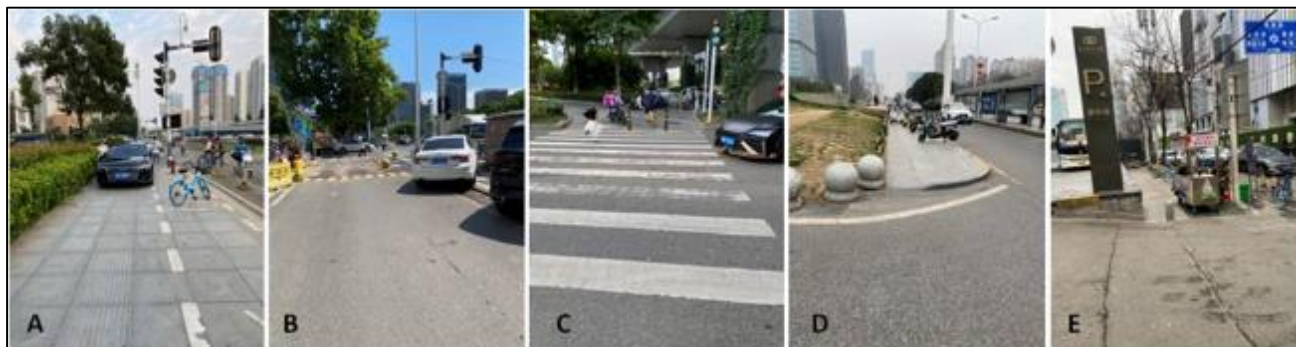
**Figure 12** A) Vehicle illegally parked on the sidewalk, B) Use of sidewalk as part of private controlled parking, C) Permitted turning of vehicles during green pedestrian crossing signal, D) Marking of bicycle parking zones on sidewalk with limited width, E) Sidewalk use by vendor hindering pedestrian flow.
